ENGINEER'S REPORT

JULIE SPRAFKA INJURY

INVESTIGATION OF THE JULIE SPRAFKA INJURY

ENGINEERING REPORT

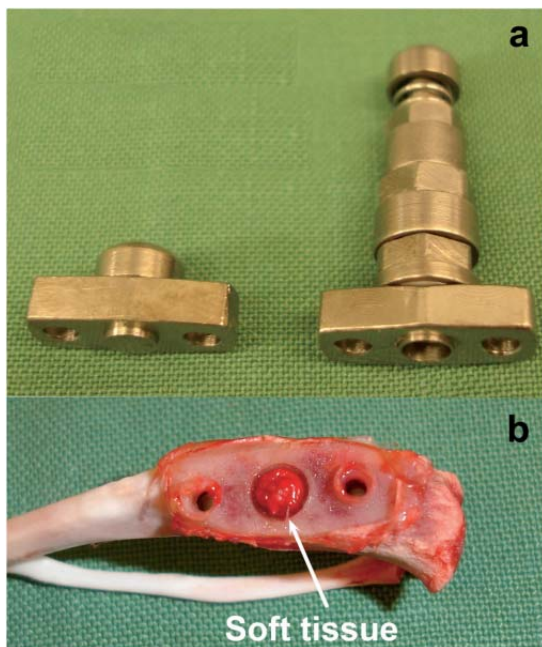
Figure 10 : (From Fahlgren et al.¹⁰⁹) a) The plate with the central plug (left) and the pressure piston (right) b) tibia showing the bone surface under the titanium plate and the newly formed soft tissue under the pressure piston.

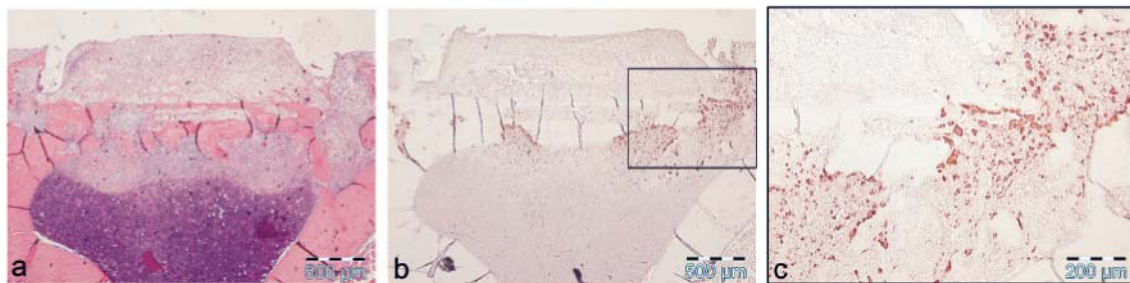
Figure 12: (From Fahlgren et al.¹¹¹) Specimen after 5 days of impact loading with different stainings. a) The soft tissue and the bone plate under the piston seen at 4× magnification (H&E), b) osteoclast activation concentrated under and beside the former piston seen at 4× magnification (immunohistochemistry for CatK), and c) activated osteoclasts within the bone plate seen at 10× magnification (CatK).

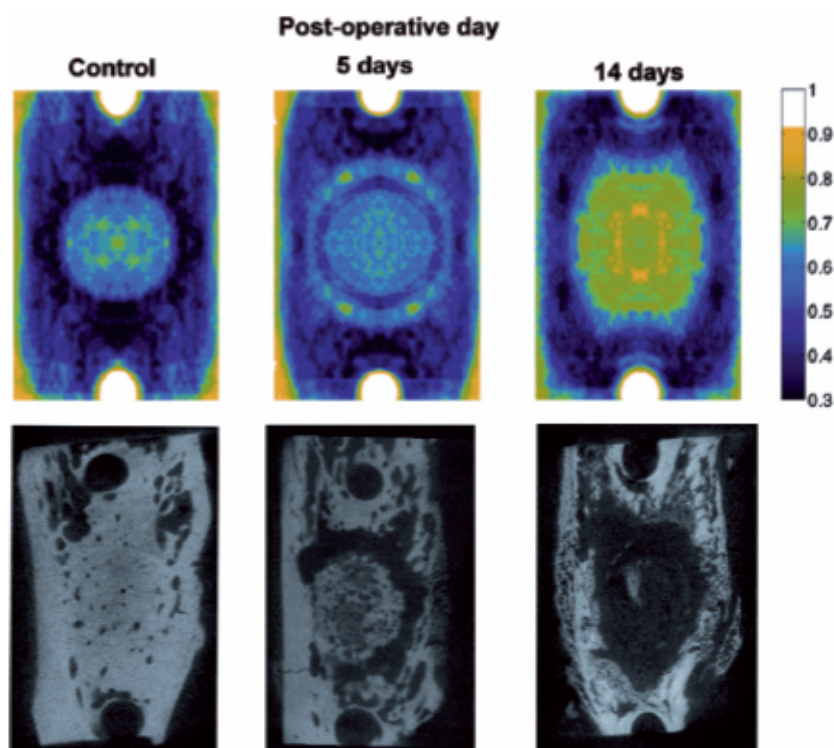
Figure 13: (From Fahlgren et al.¹¹²) Superimposed microCT scans illustrating the average distribution of the osteolytic response (top). Darkest magenta represents solid bone, cyan, green and yellow represent increasing osteolysis and white represents absence of bone. Typical samples for illustration of specific bone scans below.

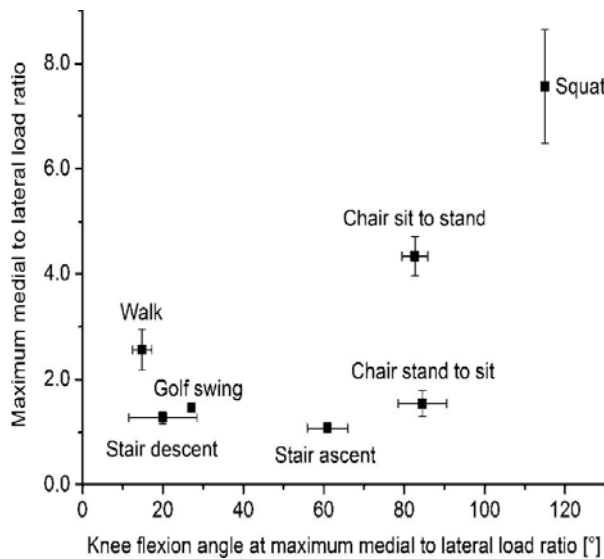
Figure 14: Maximum medial to lateral load ratio for various activities measured in TKA patients.¹²³
